DATE: November 09, 2011

SERVICE BULLETIN #20111109

SUBJECT: Inspection of the top diagonal attachment point on all Sigma Sport Tandem Systems.

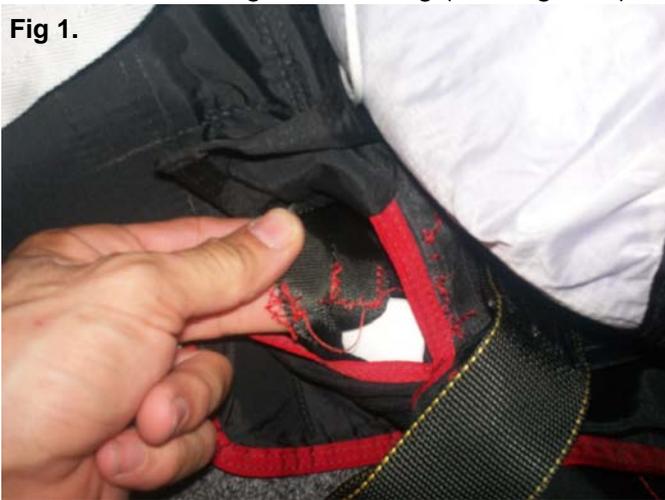
Fig 1.

BACKGROUND: During an inspection and repack, a rigger noticed the left side zigzag stitching that holds the diagonals to the top of the reserve container had completely failed and was no longer securing the container to the diagonal webbing (See Fig 1 - 2).

- Sport Sigma
- Serial # 48833
- DOM 30 Mar. 2009
- Estimated to have 1250 jumps
- Hard opening reported before damage appeared
- 3-4 reserve deployments

If the diagonals are damaged and in need of repair, riggers in the field are now authorized and requested to make this zigzag repair of the damaged area as usual, then make an additional third pass (3 total passes) in the "E" shape stitch pattern. It is the intent of the new third pass to duplicate this structural integrity on stitch patterns with a minimal stitch count.

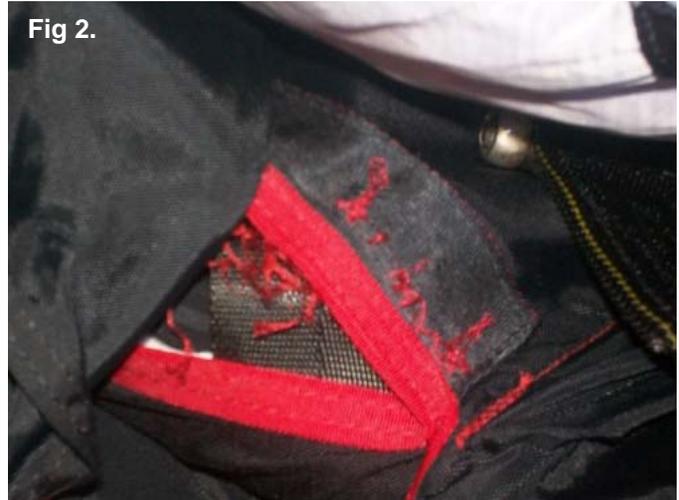
Fig 2.

NOTE: The diagonal stitching on the right side of this rig remained undamaged but also showed the stitch count to be lacking. During close examination of this stitch pattern's production history, we learned that the stitch count on a number of rigs was inadvertently reduced.

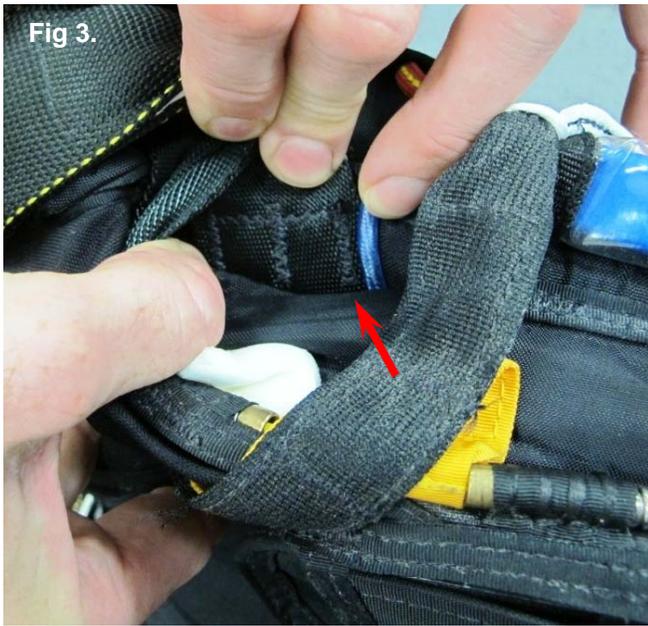
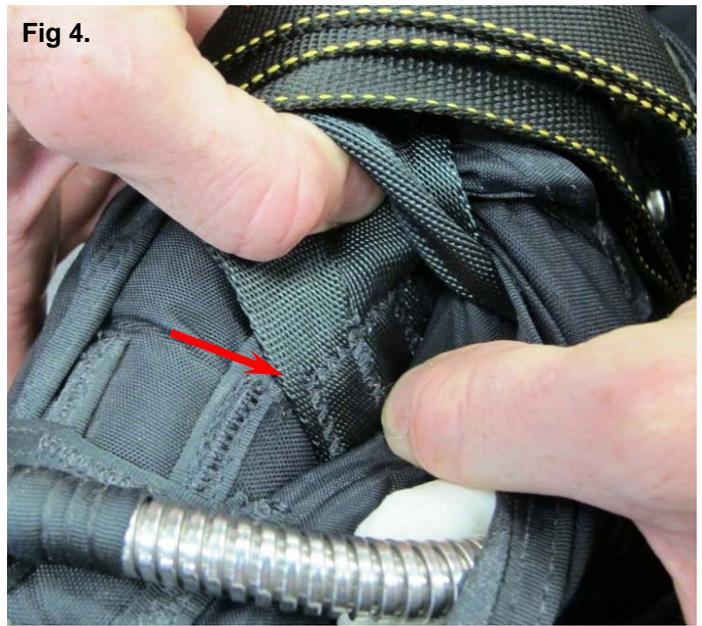
SERVICE BULLETIN: All Sigma Sport Tandem Systems are to be inspected for broken stitching at this diagonals attachment point. This can easily be done on packed rigs by simply opening the reserve pin cover and riser covers, then work your thumb up under the diagonal to expose the zigzag stitching as shown in Fig 3 (*right side*) and Fig 4 for (*left side*). Consult a rigger if you are unsure or have any questions. This inspection should take no longer than 1-2 minutes.

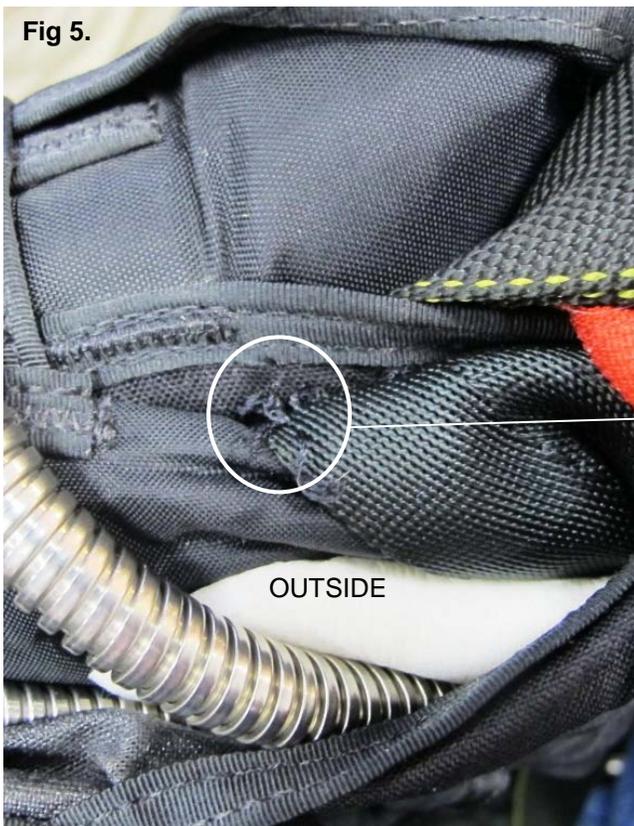
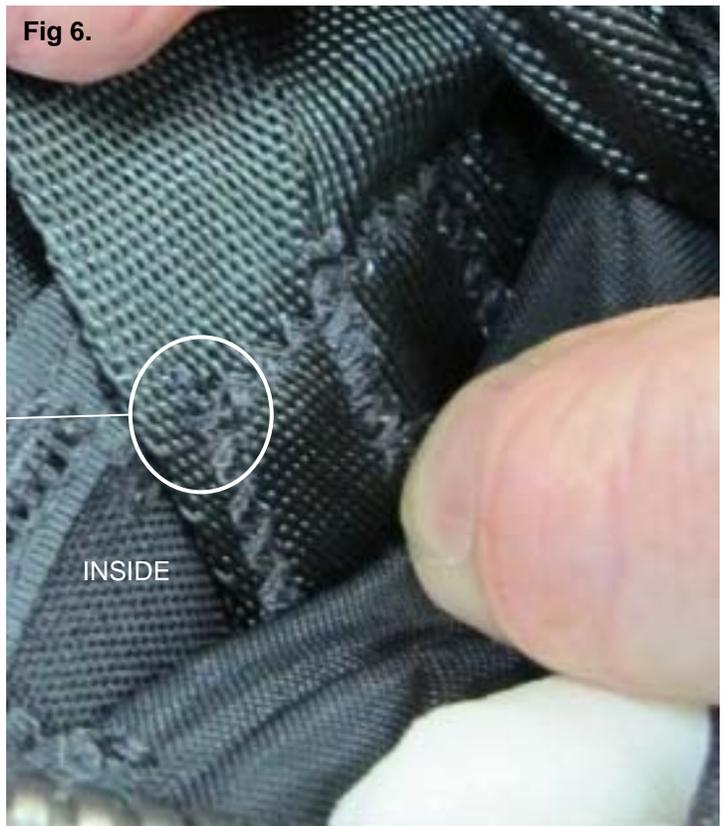
NOTE: If only very minor stitch damage is found (*up to 20%*) at this stitch pattern such as Fig 5-6, the repair can wait until its next repack.

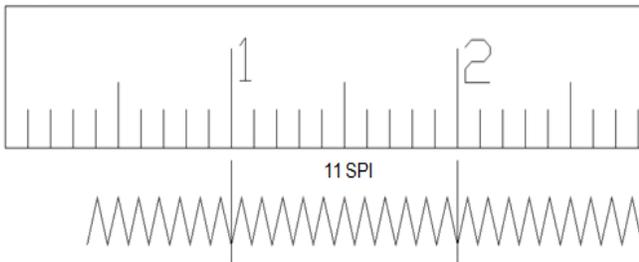
Fig 9. Counting zigzag stitches per Inch (SPI) as per Pointers Manual

NOTE: The correct stitch count for this diagonal attachment point is 10- 11 SPI (See Fig 9).

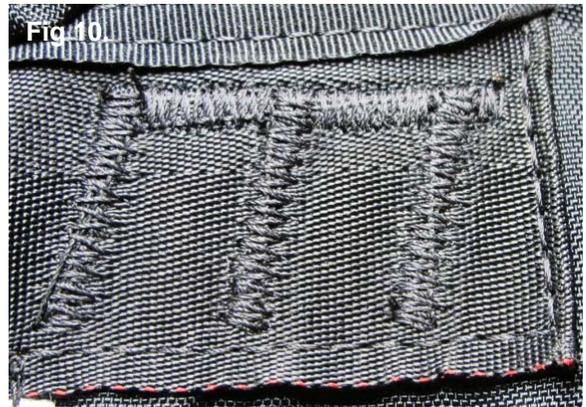
After the repair is made, inspect the inside stitching. The number of stitches per inch should appear as shown in Fig 10.
