DATE: May 23, 2011

SERVICE BULLETIN #20110523

SUBJECT: Inspection of the top diagonal attachment point on all Vector 3 Sport and SE Student Harness/Container Systems.

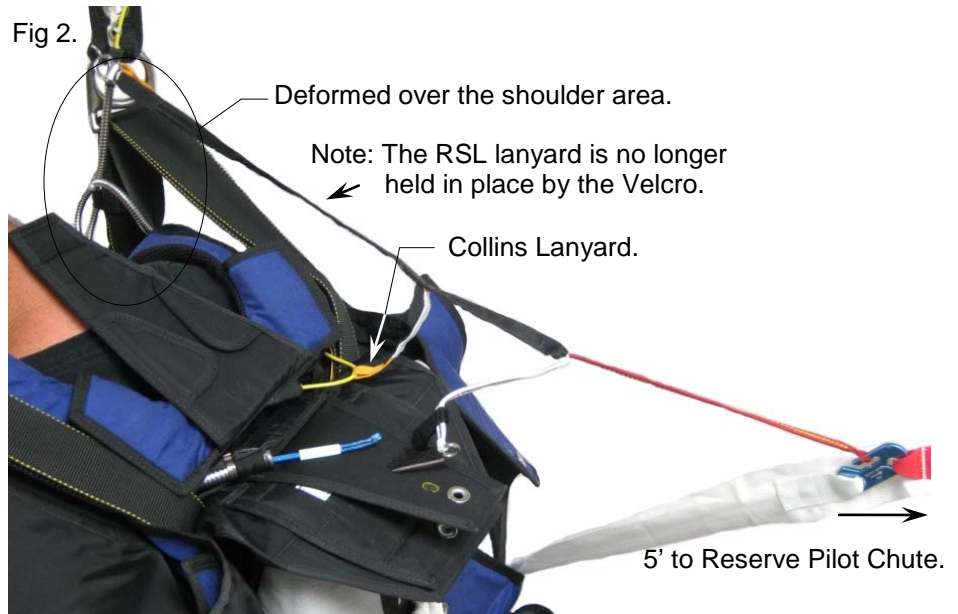
At an altitude of around 4500' the attachment point of the SkyHook and RSL lanyard produced a trailing reserve pilot chute (*preventing a two out scenario*) as witnessed from the ground (See Fig2). At an altitude reported to be between 225' and 250' the student jumper initiated a final approach turn, but due to the deformation of the right shoulder section of the harness, the Collins lanyard released the left riser from this turn input (See Fig2). The student then reacted by immediately pulling the cutaway handle releasing the right riser initiating a SkyHook direct bag deployment. After a very short reserve canopy ride, the student experienced a hard landing in a corn field.

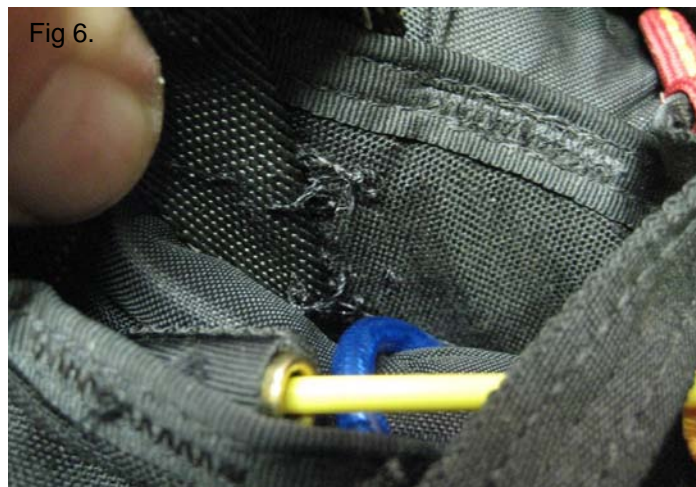
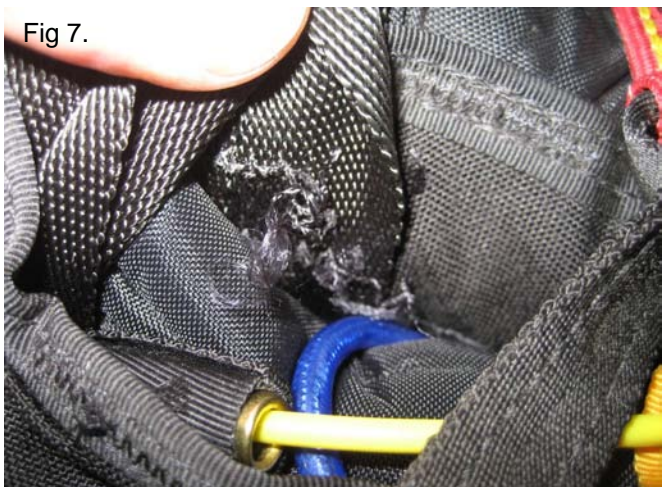
Figures 5, 6 and 7 show example of failing stitch patterns in need of repair.

If the diagonals are in need of repair, riggers in the field are now authorized and requested to make this zigzag repair using “E” shape stitch pattern. This “E” shape zigzag stitch pattern is the same pattern that has been in use on the Sigma Tandem system for some time.
