**PIA Technical Bulletin TB-241**  
**Parachute Industry Association Publications**  
March 2, 2000

Container Grommets and Small Suspension Lines

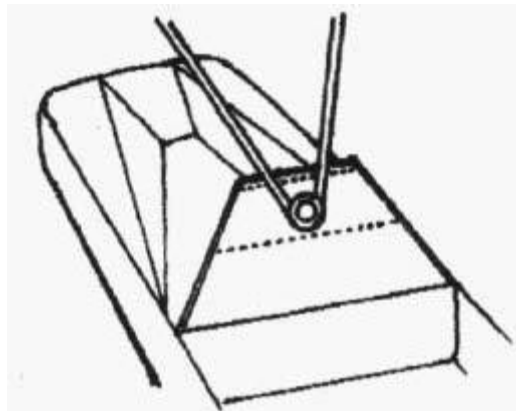
Because of two recent fatalities involving relatively small suspension lines snagging on container grommets, as well as other similar incidents not resulting in fatalities, the PIA Technical Committee recommends:

Figure 1 -Suspension-line snagged around improperly seated container flap grommet.

- 1) All container grommets should be inspected to ensure that they are properly set. See figure 1.
- 2) On main containers with a “main closing loop webbing anchor”, users/riggers should contact the manufacturer for their current recommendations. See Figures 2 and 3.
- 3) Because of design specific issues, PIA further requests that all equipment manufacturers individually address these issues and disseminate relevant information to the field.

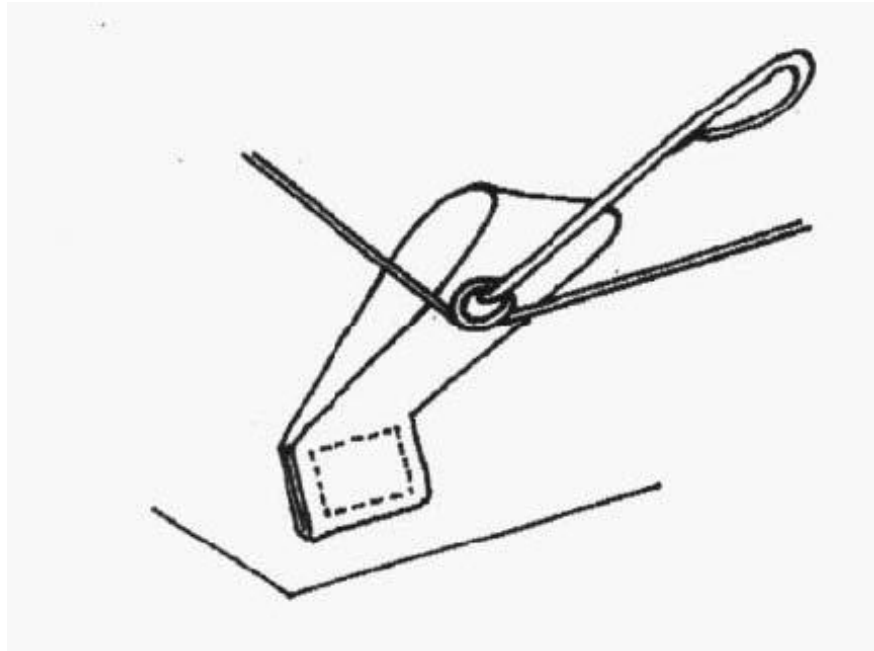
Figure 2 - Suspension line snagged around grommet on main loop anchor

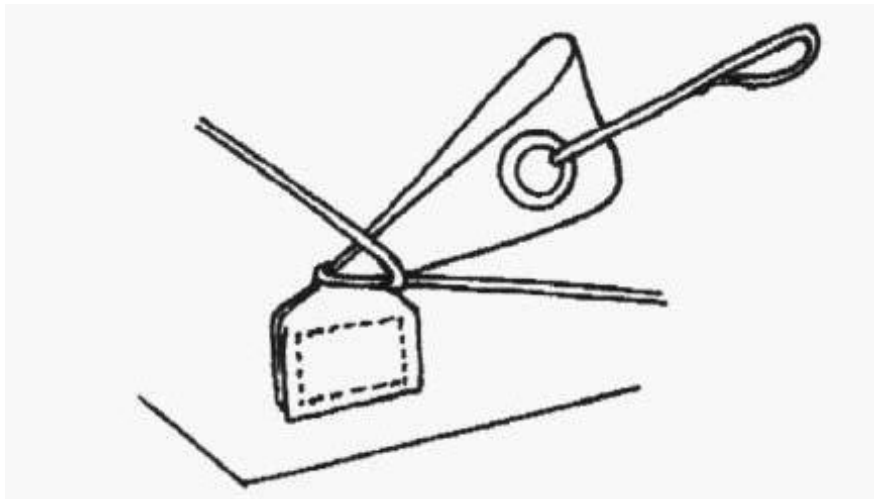
Figure 3 - Suspension line half-hitched about main loop anchor
