## PRODUCT SERVICE BULLETIN

Bulletin Number: FB 2021-01

SUBJECT: Firebird V1R1 EVO Harness container systems with adjustable Main Lift Web

STATUS: MANDATORY INSPECTION BEFORE NEXT JUMP

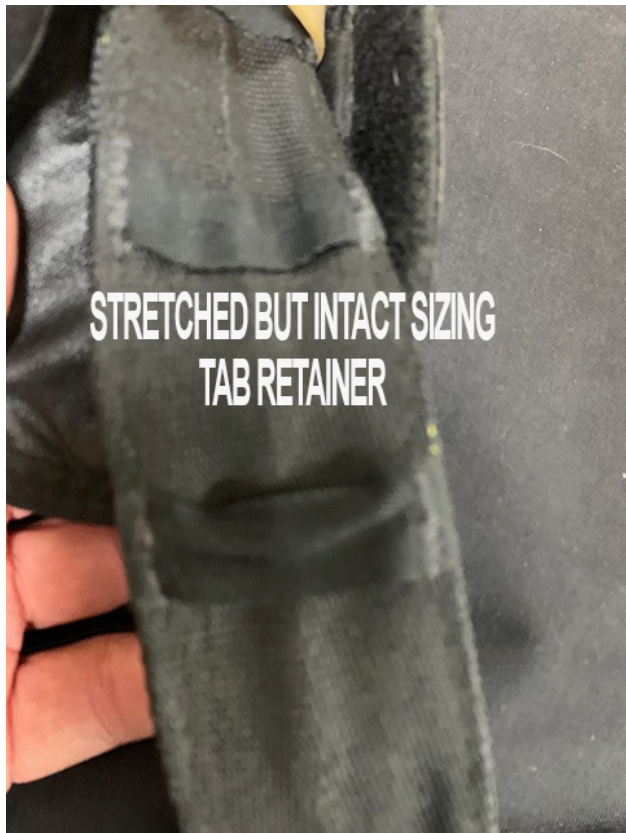
**Right** Main lift web undone, sizing safety tab ripped off and stuck under a stretched but intact sizing tab retainer (1/2" type 1), 555-2 ring installed **correctly**, **missing** spring, **NO** damage to type 4 stopper.

From the stretch marks of the sizing tab retainer, we think that the misrouting happened not too long ago by a third party during the rental process and that it went unnoticed for an unknown period by anyone involved in the rental process and handling of the container.

#### Stretched tab retainer

To make sure that in the future only qualified Riggers can disassemble the main lift web, we strongly recommend replacing the type 4 stopper with four layers of type 17 webbing and sew a BOX X pattern with at least 5-cord. Firebird USA LLC uses exclusively 6-cord.

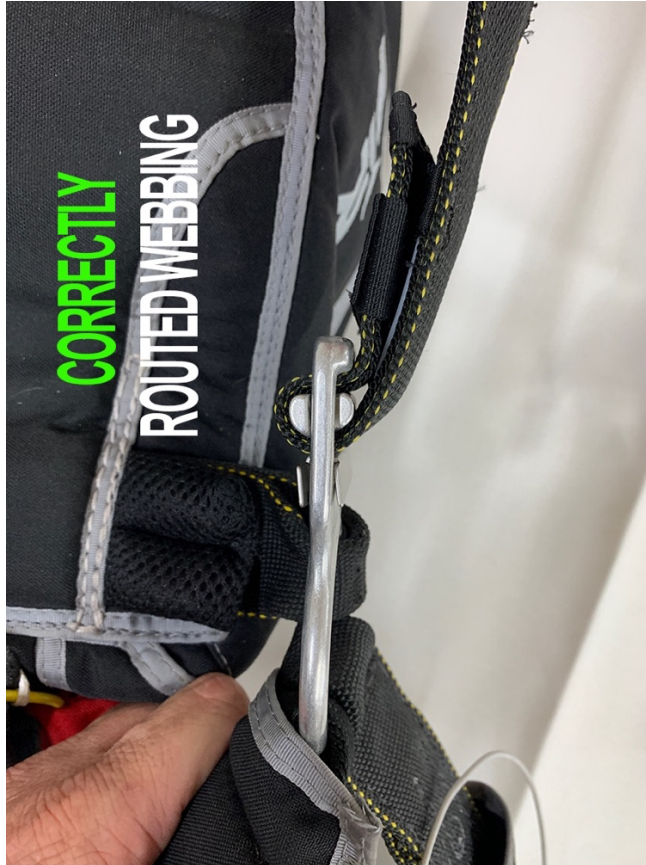
**Side view**

**!!!! CORRECT ROUTING !!!!**
