**SERVICE
BULLETIN**

1. Issue Date : **September 30, 2016**
2. Bulletin number : **02/09/2016**
3. Subject : **m2 AAD Cutter Replacement**
4. Status : **Mandatory**
5. Identification : **Identification of affected m2 AAD cutters**

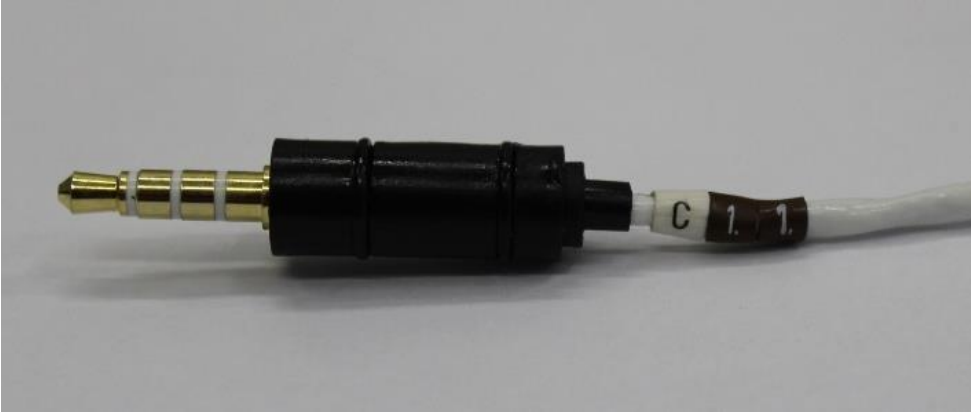
Fig. 2 Series C, year 2011 (marked on cutting unit cable)

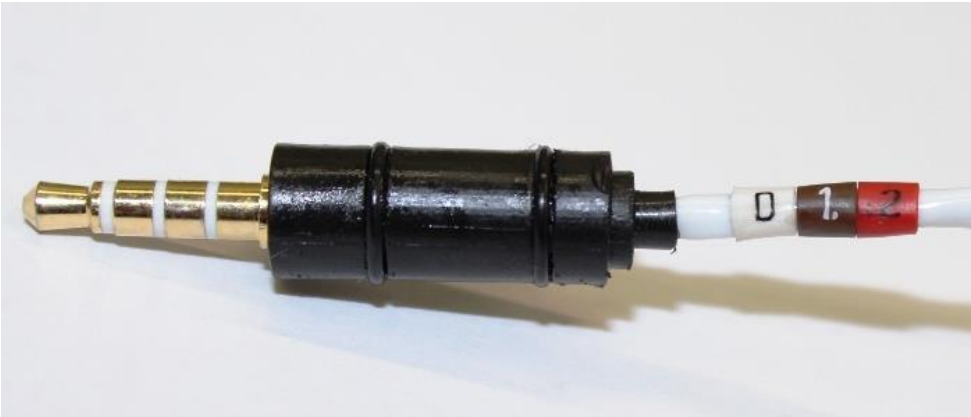
Fig. 3 Series D, year 2012 (marked on cutting unit cable)

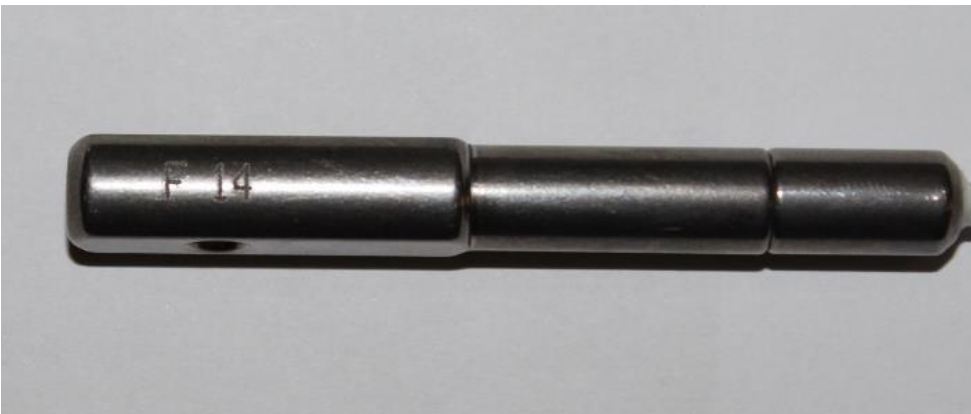
Fig. 4 Series F, year 2014 (marked on cutting unit cable)
