Product Service Bulletin

- *Issue Date:* 10 September 2020
- **PSB Number:** PSB-10092020
- Identification: After-market <u>Tandem Main Risers</u> constructed with obsolete <u>RW2 rings</u>. All sport tandem main risers produced with RW2 rings, or equivalent sized rings, are affected regardless of the hardware manufacturer, the date of manufacture, the material type or the forging process used. This PSB <u>does not affect</u> "solo" main risers that use RW2 rings.

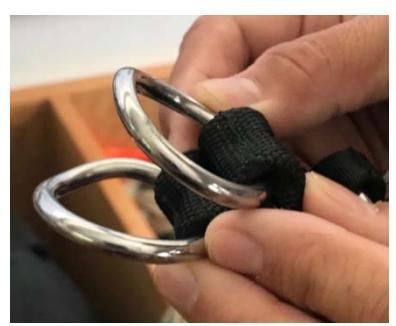
Figure-2

Background: Recent reports of "bent rings" on tandem main risers are of great concern. At least one after-market manufacturer of obsolete and unapproved tandem risers is using RW2 rings or similar rings, which were discontinued for tandem use in 1996 due to "bent ring" issues. These rings pass a proof load of 500 lbs. and begin to distort at 2500 lbs.

Two (2) sets of tandem risers were recently discovered with bent rings. This pair bent after one (1) jump; a second pair had approximately 30 jumps.

Compliance: MANDATORY – REPLACE BEFORE THE NEXT JUMP.

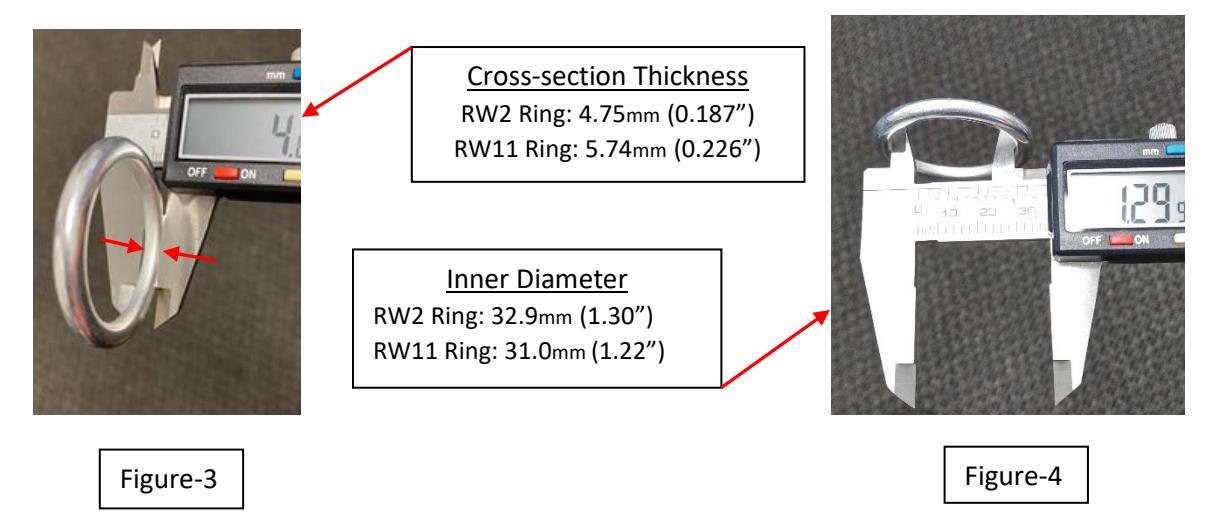
RW2 rings (or similar size rings) have a cross-section thickness of less than 5mm (0.197"). Risers with these dimensions should be permanently grounded for tandem use.

The inner diameter ring dimensions are also provided (Figure-4) as further verification of the ring type.

Use a digital caliper to accurately measure the cross-section thickness of the ring. Refer to *Figure-3* below for proper caliper/ring interface while measuring. The riser should be disconnected from the harness base ring to accurately obtain a measurement.
