SERVICE BULLETIN VSESB001

SUBJECT: MAIN RISER, LOCKING LOOP WEAR

STATUS: MANDATORY INSPECTION

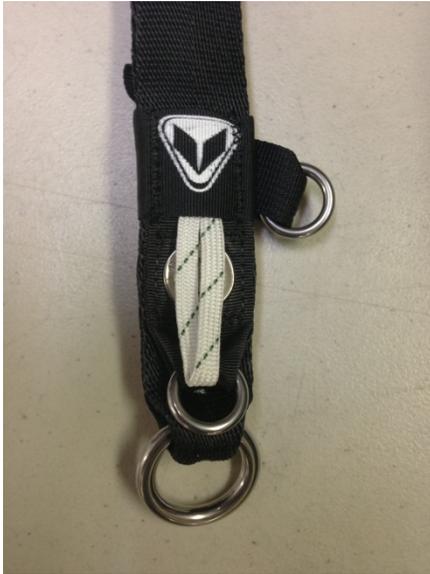
Figure 3: New Locking Loop

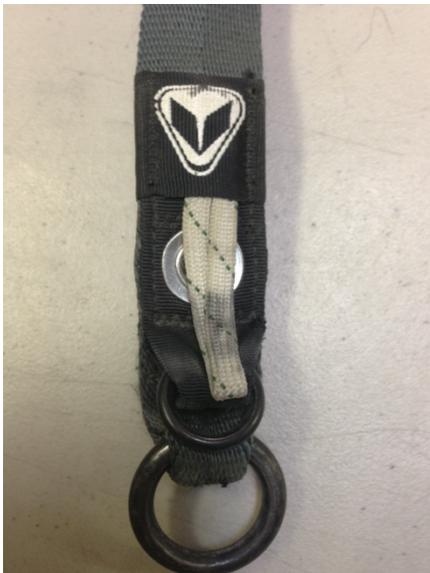
Figure 3: Normal Wear, Front

If the loop shows normal wear, the rig can continue to be jumped and no immediate repair is needed.

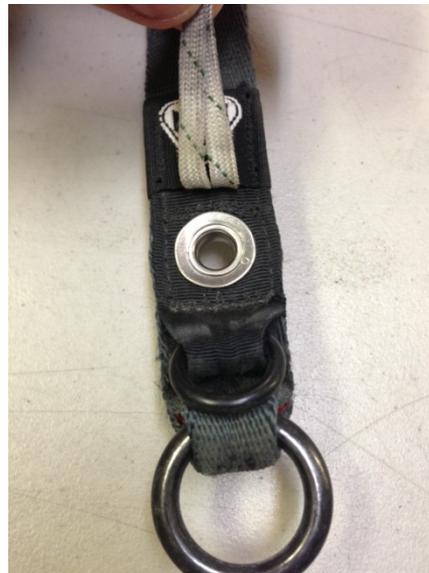
Figure 4: Normal Wear, Back

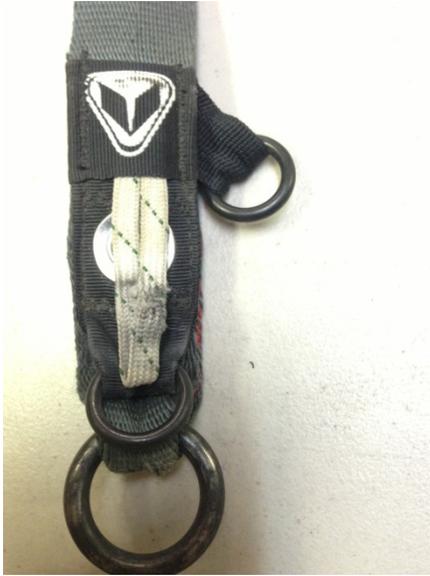
The following pictures show locking loops with damage; heavily frayed and partially cut.

Figure 5: Damaged, Frayed

If the loop shows signs of damage, the rig should not be jumped and VSE should be contacted for further instructions. VSE may also ask for additional information to help determine the root cause and most effective repair. At minimum, VSE will need 2-4 photos, one of each riser loop and one of each housing grommet. Please have these available to send to VSE when you call in. In most cases, once the root cause is determined, VSE will provide a parts kit which can be installed by an FAA certified senior or master parachute rigger or foreign equivalent using the Housing Replacement Procedure provided at the end of this service bulletin. In certain cases, VSE will require the rig be returned to VSE for further inspection and repair.

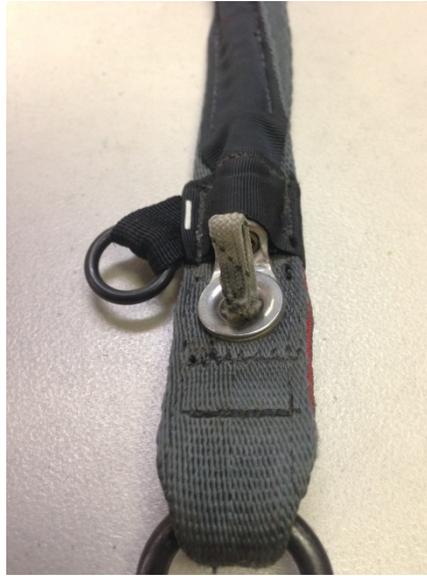
Figure 6: Damaged, Frayed

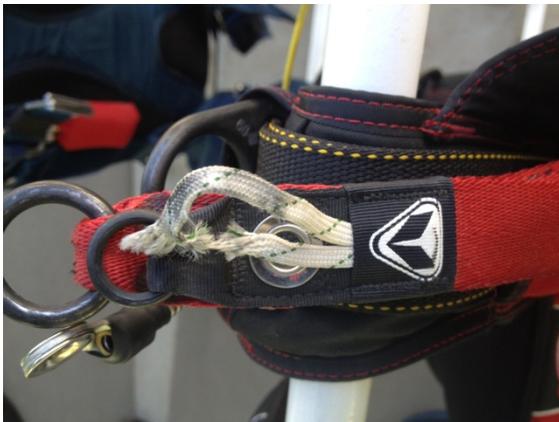
Figure 9: Damaged, Partially Cut

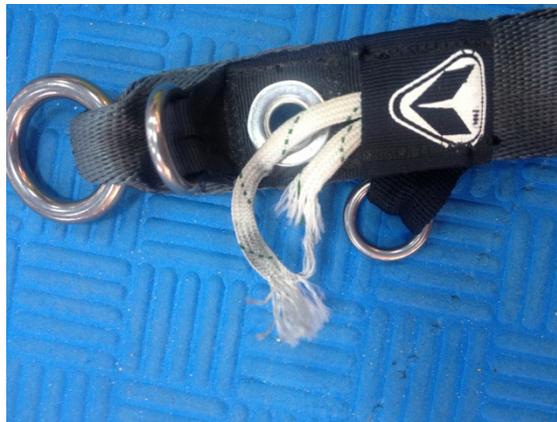
Figure 10: Damaged, Partially Cut
