PRODUCT INFORMATION BULLETIN

Bulletin Number : **PIB-01-2026**

Subject : **Vigil Cutter Service Life**

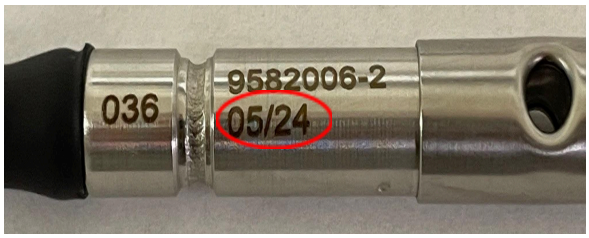
Vigil Cutter DOM MM/YY
