# Manufacturer Product Service Bulletin

## Number CW03-01

**Subject:** Capewell Supplied Pins and Ripcords

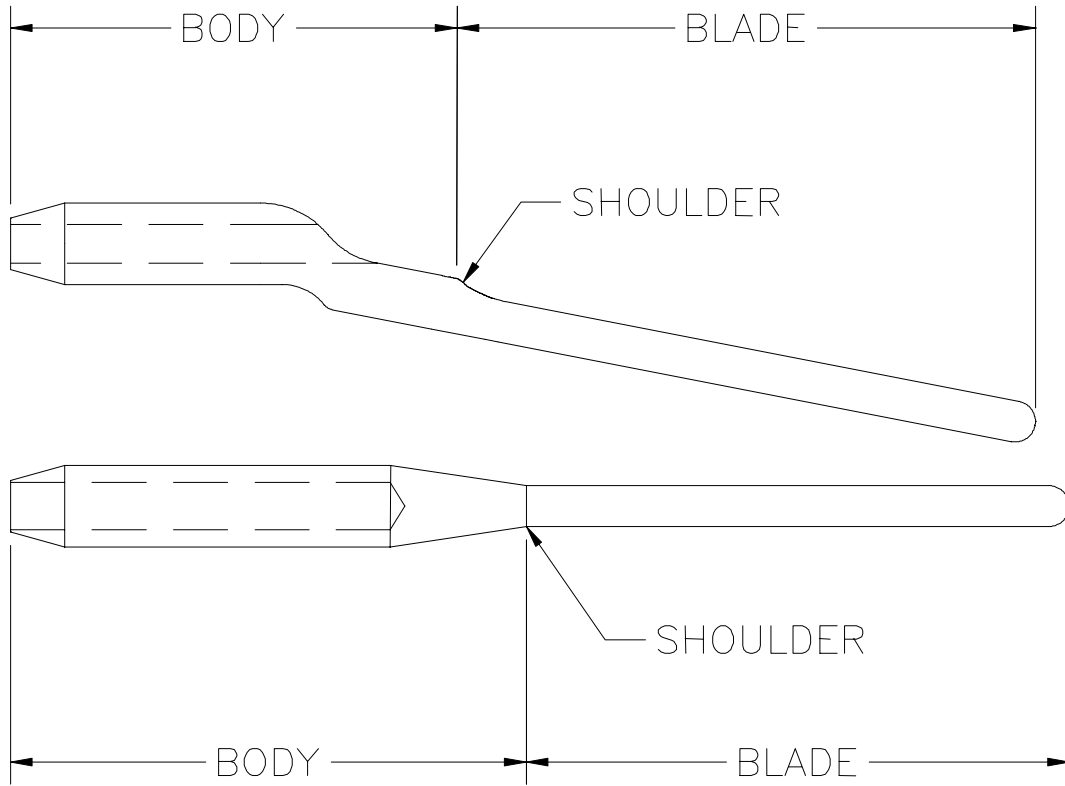
The figure below is provided for clarity to all procedural instructions.

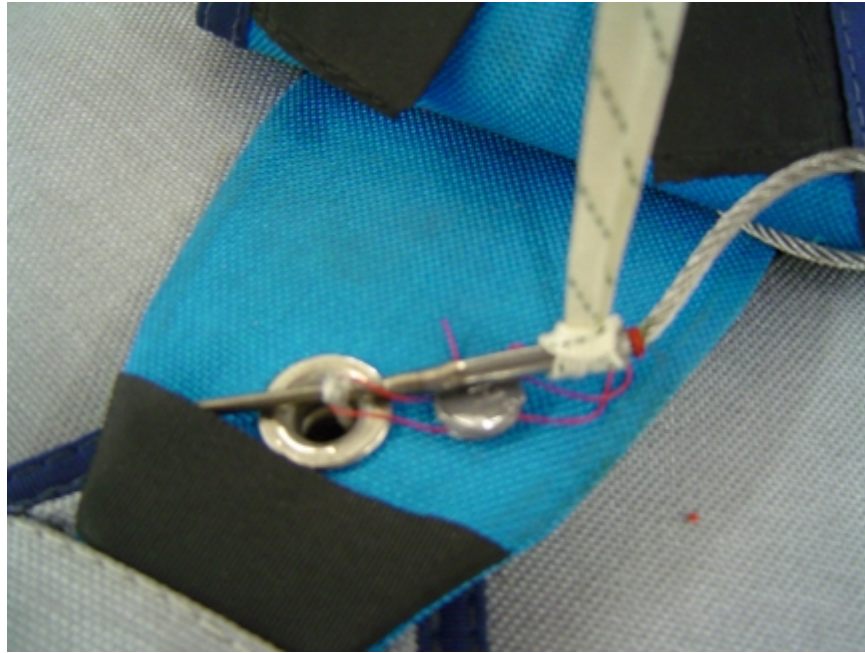
**FIGURE 1**

3. Take the suspension line and tie the two ends together with an overhand knot forming a loop.
4. Route the loop around the body of the pin to form a lark's head knot as close to the cable entrance end of the pin body as possible (Fig. 1).

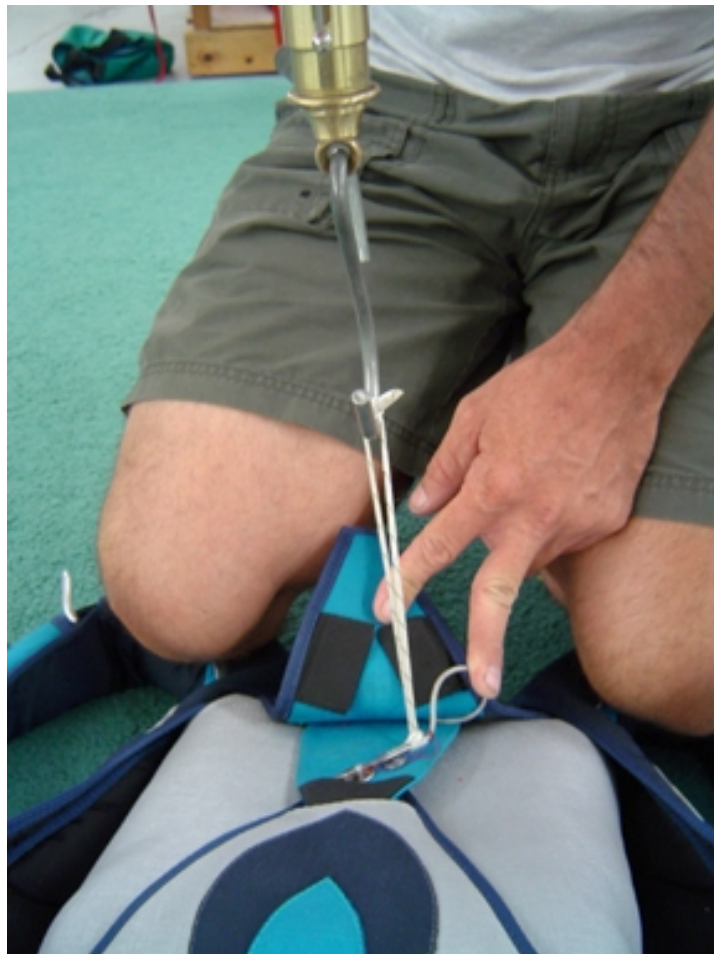
**FIGURE 2**

5. Secure the other end of the loop to the spring scale.
6. Apply a load of 15 lbs. (6.8kg) straight up and 90 degrees to the axis of the pin for a period of 3 seconds and then release the load (Fig. 2). Inspect the pin for any deformation or bend. If the pin is straight, continue with step 7 below. If the pin is not straight, as visible without magnification, remove the pin/ripcord from service immediately.

7. Mark the inspected side of the pin with the felt marker to avoid repeatedly testing the same side of the pin.
8. Rotate the pin one-quarter turn and test again as in step 6.

9. Repeat the procedure in step 6 until the pin has been tested in four positions and rotated one-quarter turn in the same direction prior to each test.

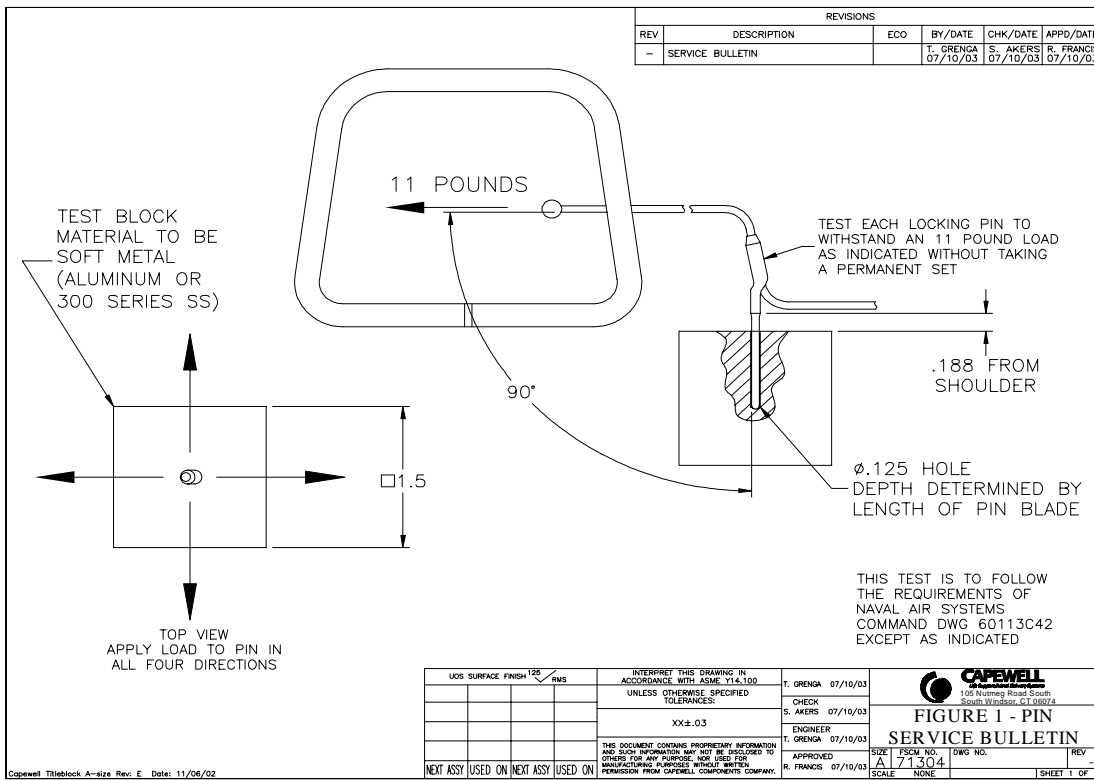
**FIGURE 3**  
All dimension in inches

1. Place pin in test block per Figure 3 (below). NOTE: The pin block hole may be VERTICAL or HORIZONTAL
2. Apply 11 lb. force 90 degrees perpendicular to the pin blade.

3. Remove pin from block and inspect:
  - For straightness: Pins in excess of .005 (.12 mm) deformation along the blade of the pin should be removed from service.

- For surface anomalies using 10x magnification. If any surface anomalies (dents, cracks, chips) exist, the pin should be removed from service.
4. Mark the inspected side of the pin with the felt marker to avoid repeatedly testing the same side of the pin

5. Repeat steps 1 through 3, each time rotating the pin 90 degrees in the same direction, until the pin has been tested in 4 directions.
6. Upon successful completion of test, ripcord handle will be marked with **CW03-01**.
